# Littlefield Dam Removal

## 100% Design Report - DRAFT

**SUBMITTED TO**  
The City of Auburn, ME

**PREPARED BY**  
Inter-Fluve  
181 Main St, 2<sup>nd</sup> Fl.  
Damariscotta, ME 04543

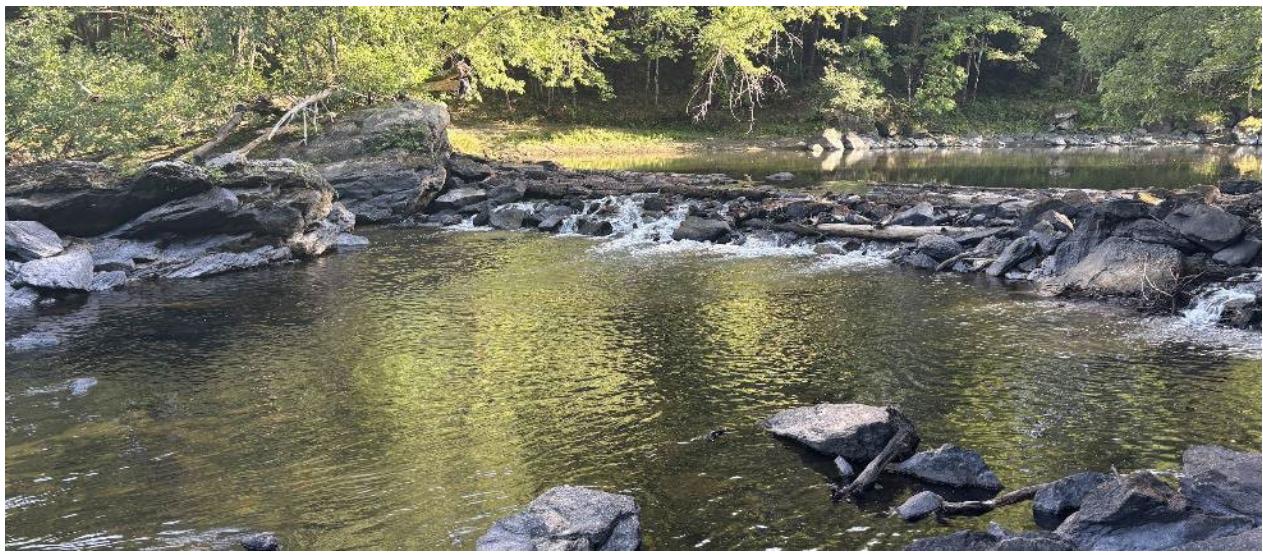
**Figure 3. Looking upstream at the remnant dam. Photo taken August 28, 2025.**

Approximately 540 feet upstream of the Dam, we discovered a remnant dam during the site survey (Figure 3). The timber and rock structure creates a drop of approximately 2 feet under low flow conditions. The volume of material is approximately 50 CY. The remnant dam may present a fish passage barrier at low flow and is therefore being considered for removal as a part of the Project.

The design also calls for the removal of the remnant rock and timber dam, which was discovered during field visits and sits approximately 400 feet upstream of the Littlefield Dam. With the Littlefield Dam removed and its impoundment eliminated, the remnant dam would likely impair fish passage. This is shown in the modeling and was evident during field visits at low water levels. The remnant dam is constructed of timbers and stone. The timbers will be disposed of offsite. The rock component of the dam will be dismantled and redistributed onsite in a manner that will not impact site hydraulics.
