CITY OF AUBURN, MAINE Demolition of 7 Chestnut BID#2025-015

Re: Asbestos Demolition Impact Survey | Residential Structure - Former Beal's Linen Site 7 Chestnut Street | Auburn, Maine

ASBESTOS DEMOLITION IMPACT SURVEY

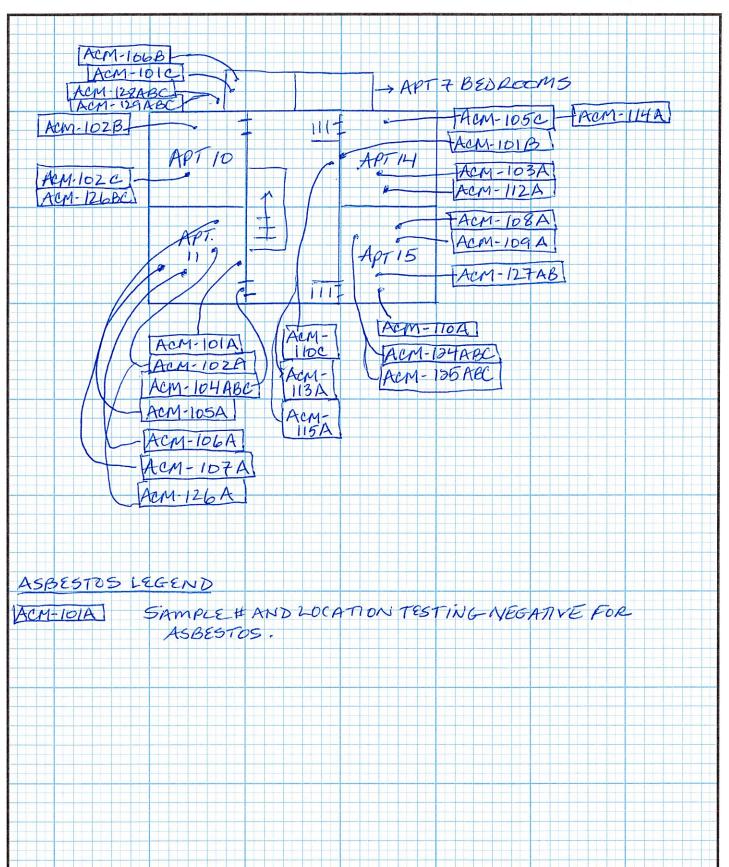
SUBJECT: 7 CHESTNUT ST. AUBURN - 2nd FLOOR

Sample numbers and locations are included on the attached Field Sketches (Attachment D).

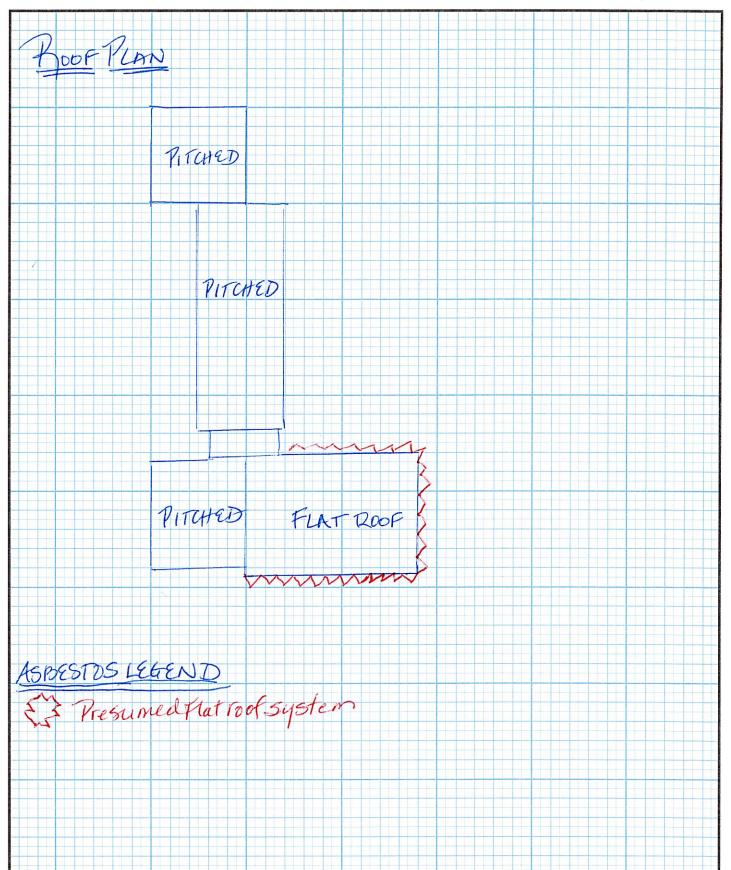
SUBJECT: 7 CHESTNUT ST. AUBURN, - ROOF

The flat roofing system present on the two-story portion of the building was not safely accessible during the completion of this Asbestos Demolition Impact Survey, and the associated asphalt-based roofing materials were not sampled. The roofing components associated with this flat roofing system should be presumed to be asbestos-containing. These materials should be sampled and submitted for laboratory analysis, during demolition and prior to disposal, to determine if they are asbestos-containing,
